# Alderwood South Apartments

## *Drainage Report*

Job No: 17-166

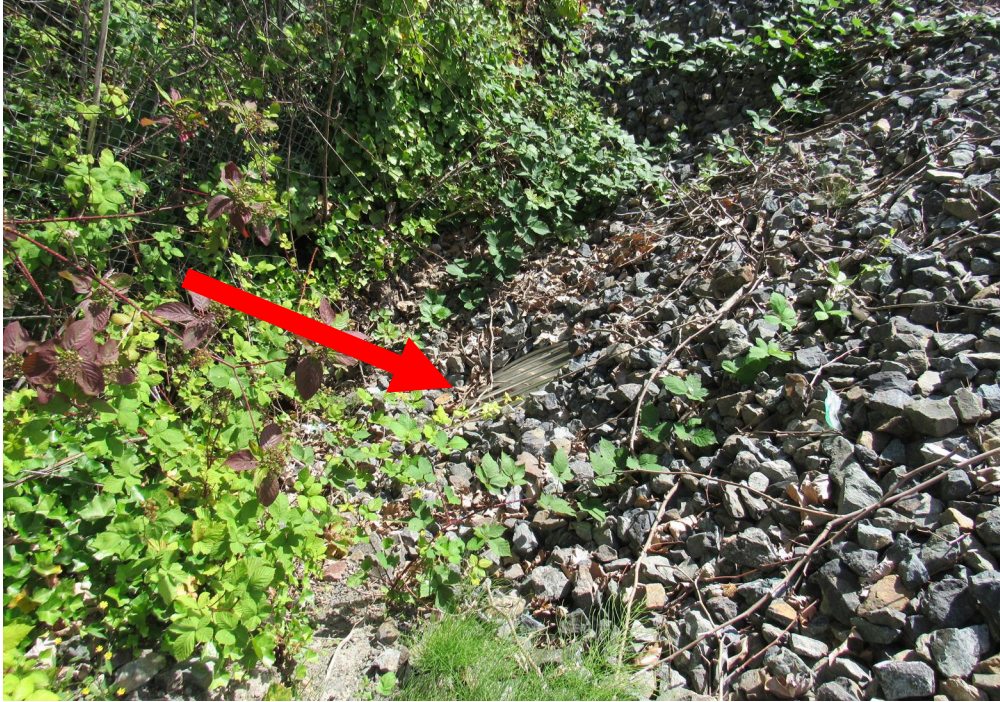
Image①: Runoff from upstream basin enters onsite and into debris barriered intake pipe.

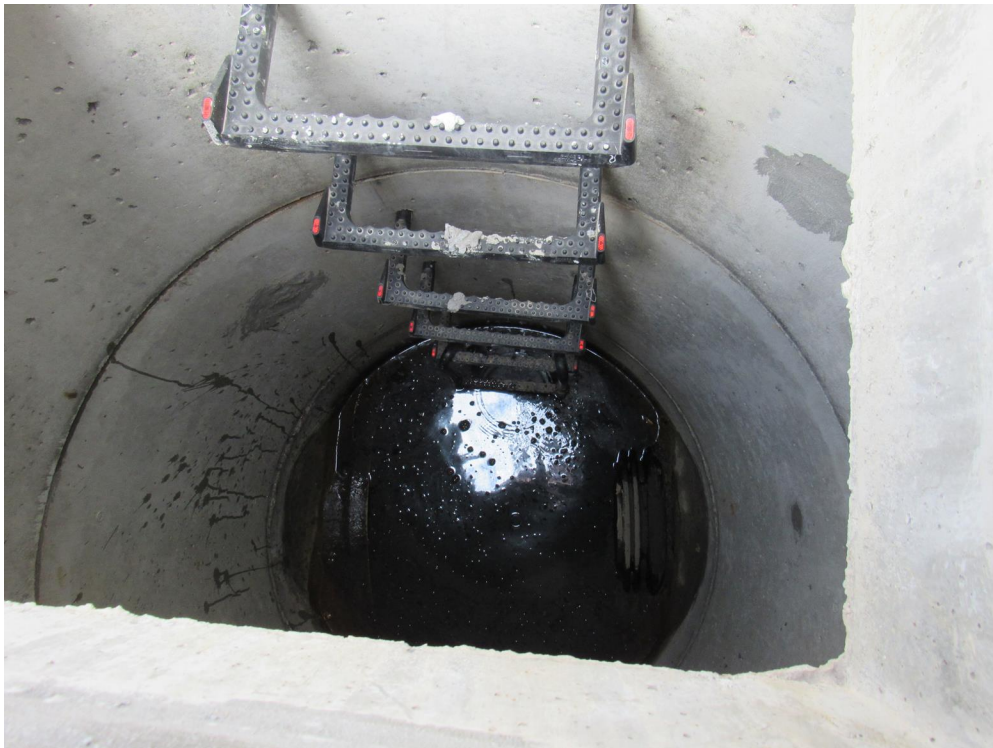
Image②: Intake pipe continues south on site into deep manhole (right pipe) continues directing flow south (left pipe).

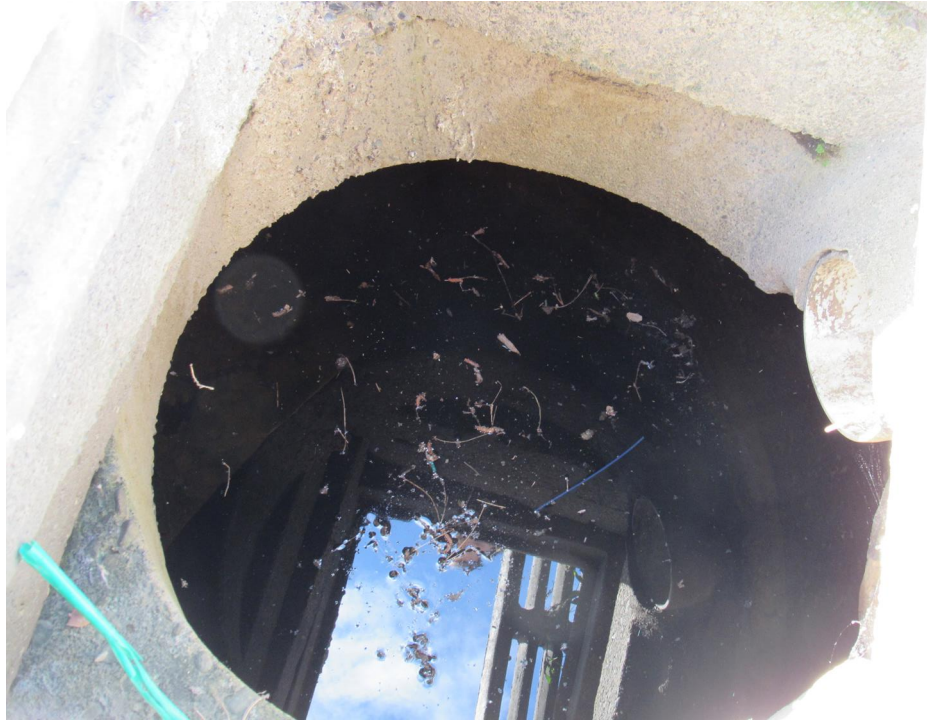
Image⑨: Flow enters another catch basin (left submerged pipe) and is redirected southeast in submerged pipe (right).

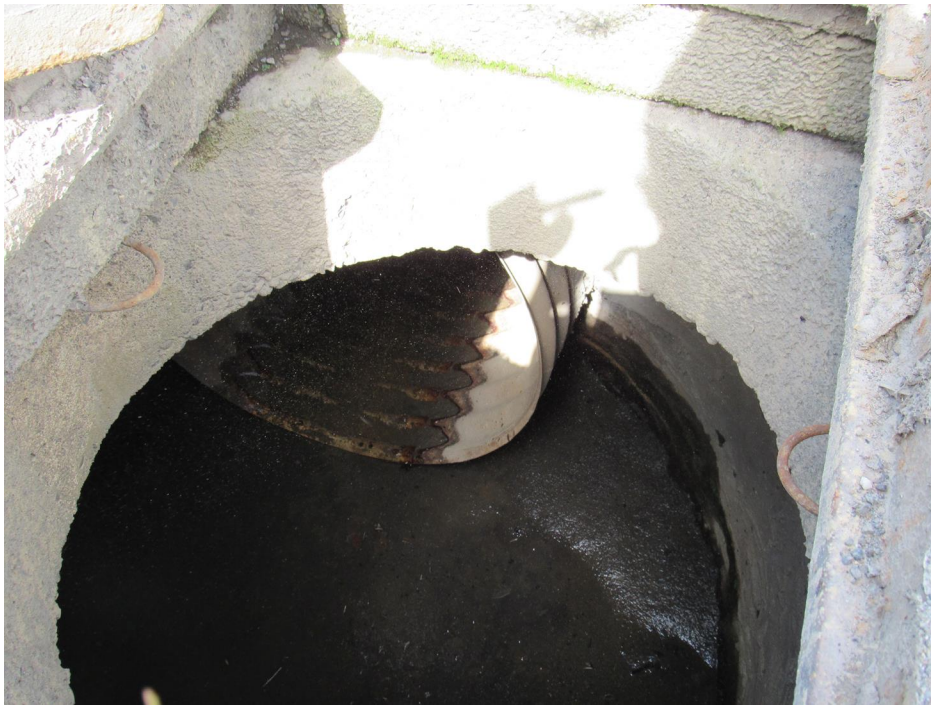
Image④: Flows enters catch basin and continues southeast off site.

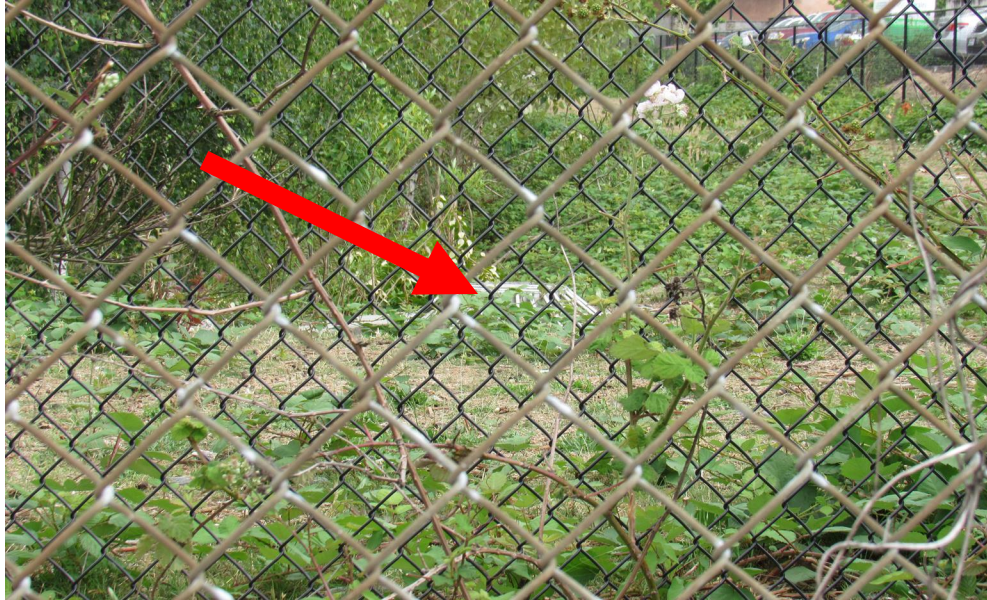
Image⑤: Flow enters into 54" debris caged manhole entering the site in the northern border.

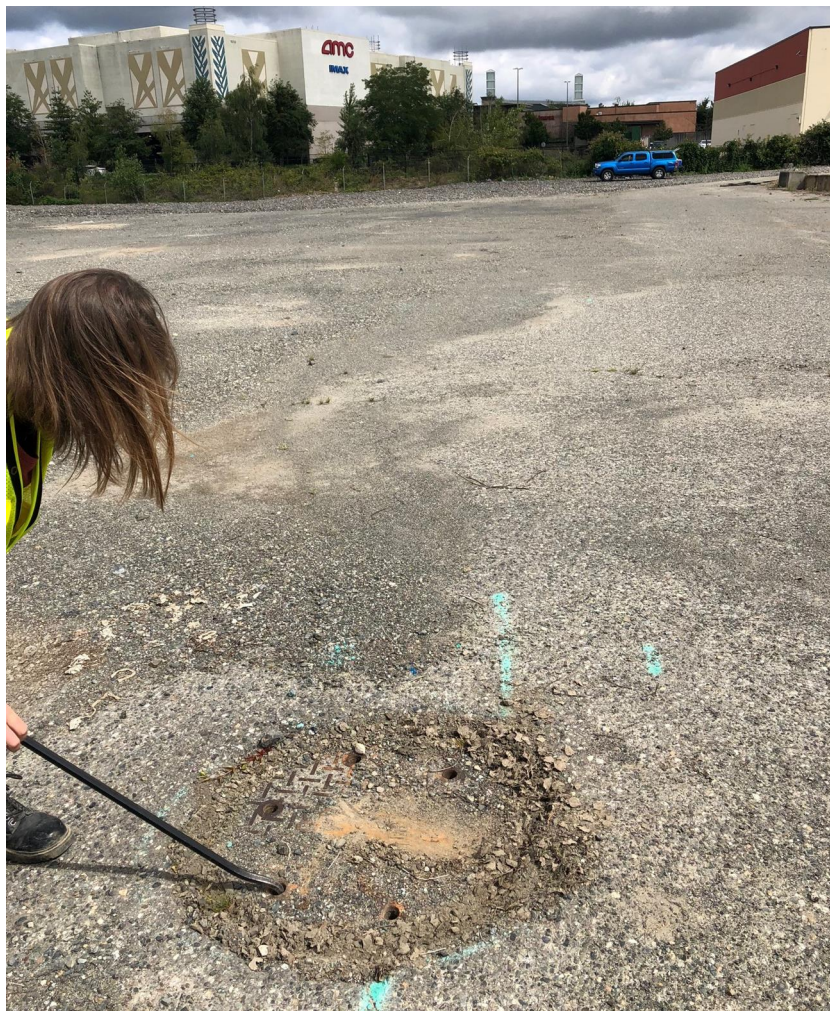
Image⑥: Flow is directed south into a solid lid catch basin system

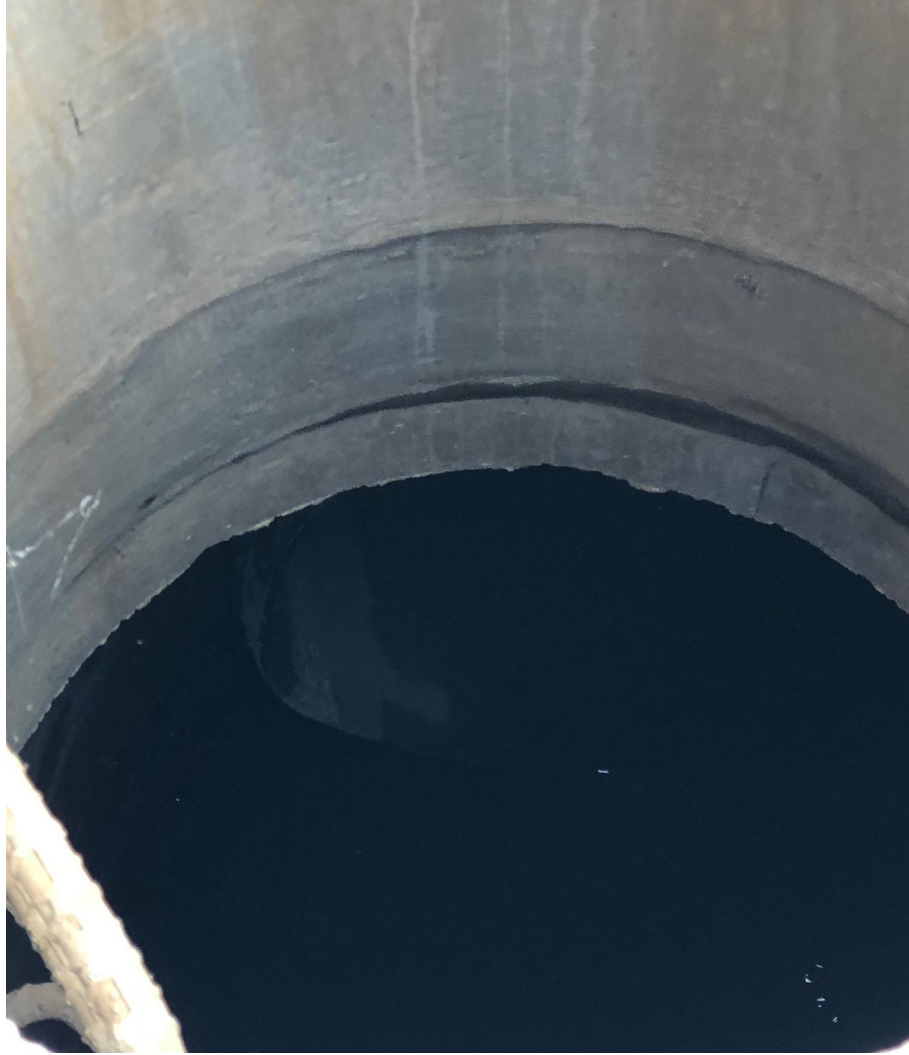
Image 7: Flow enters into another downstream deep catch basin and is directed south east offsite under Interstate 5.

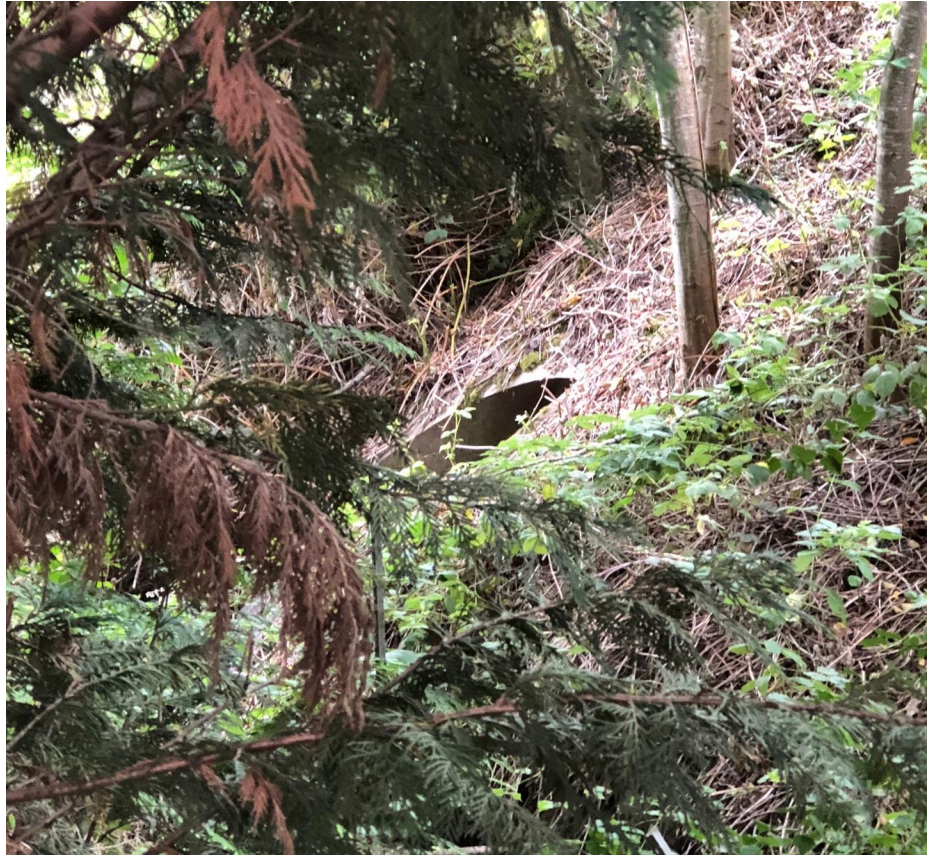
Image⑧: After flow travels under Intersate 5, flow is discharged from 54" pipe into a protected wetland.

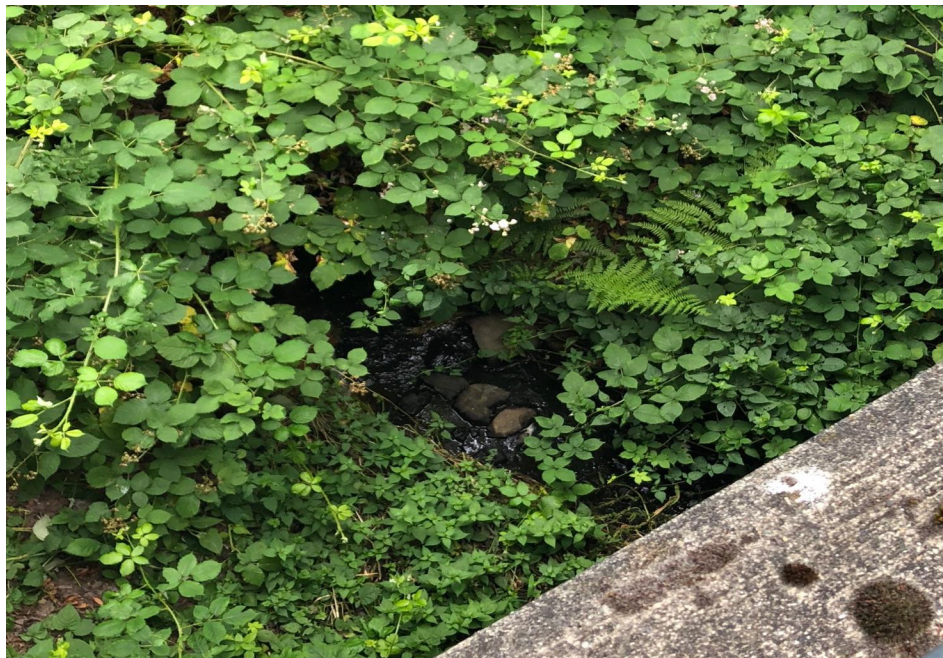
Image⑨: Flow travels through wetland to culvert intake at 196<sup>th</sup> St SW when it crosses 0.25 mile boundary.

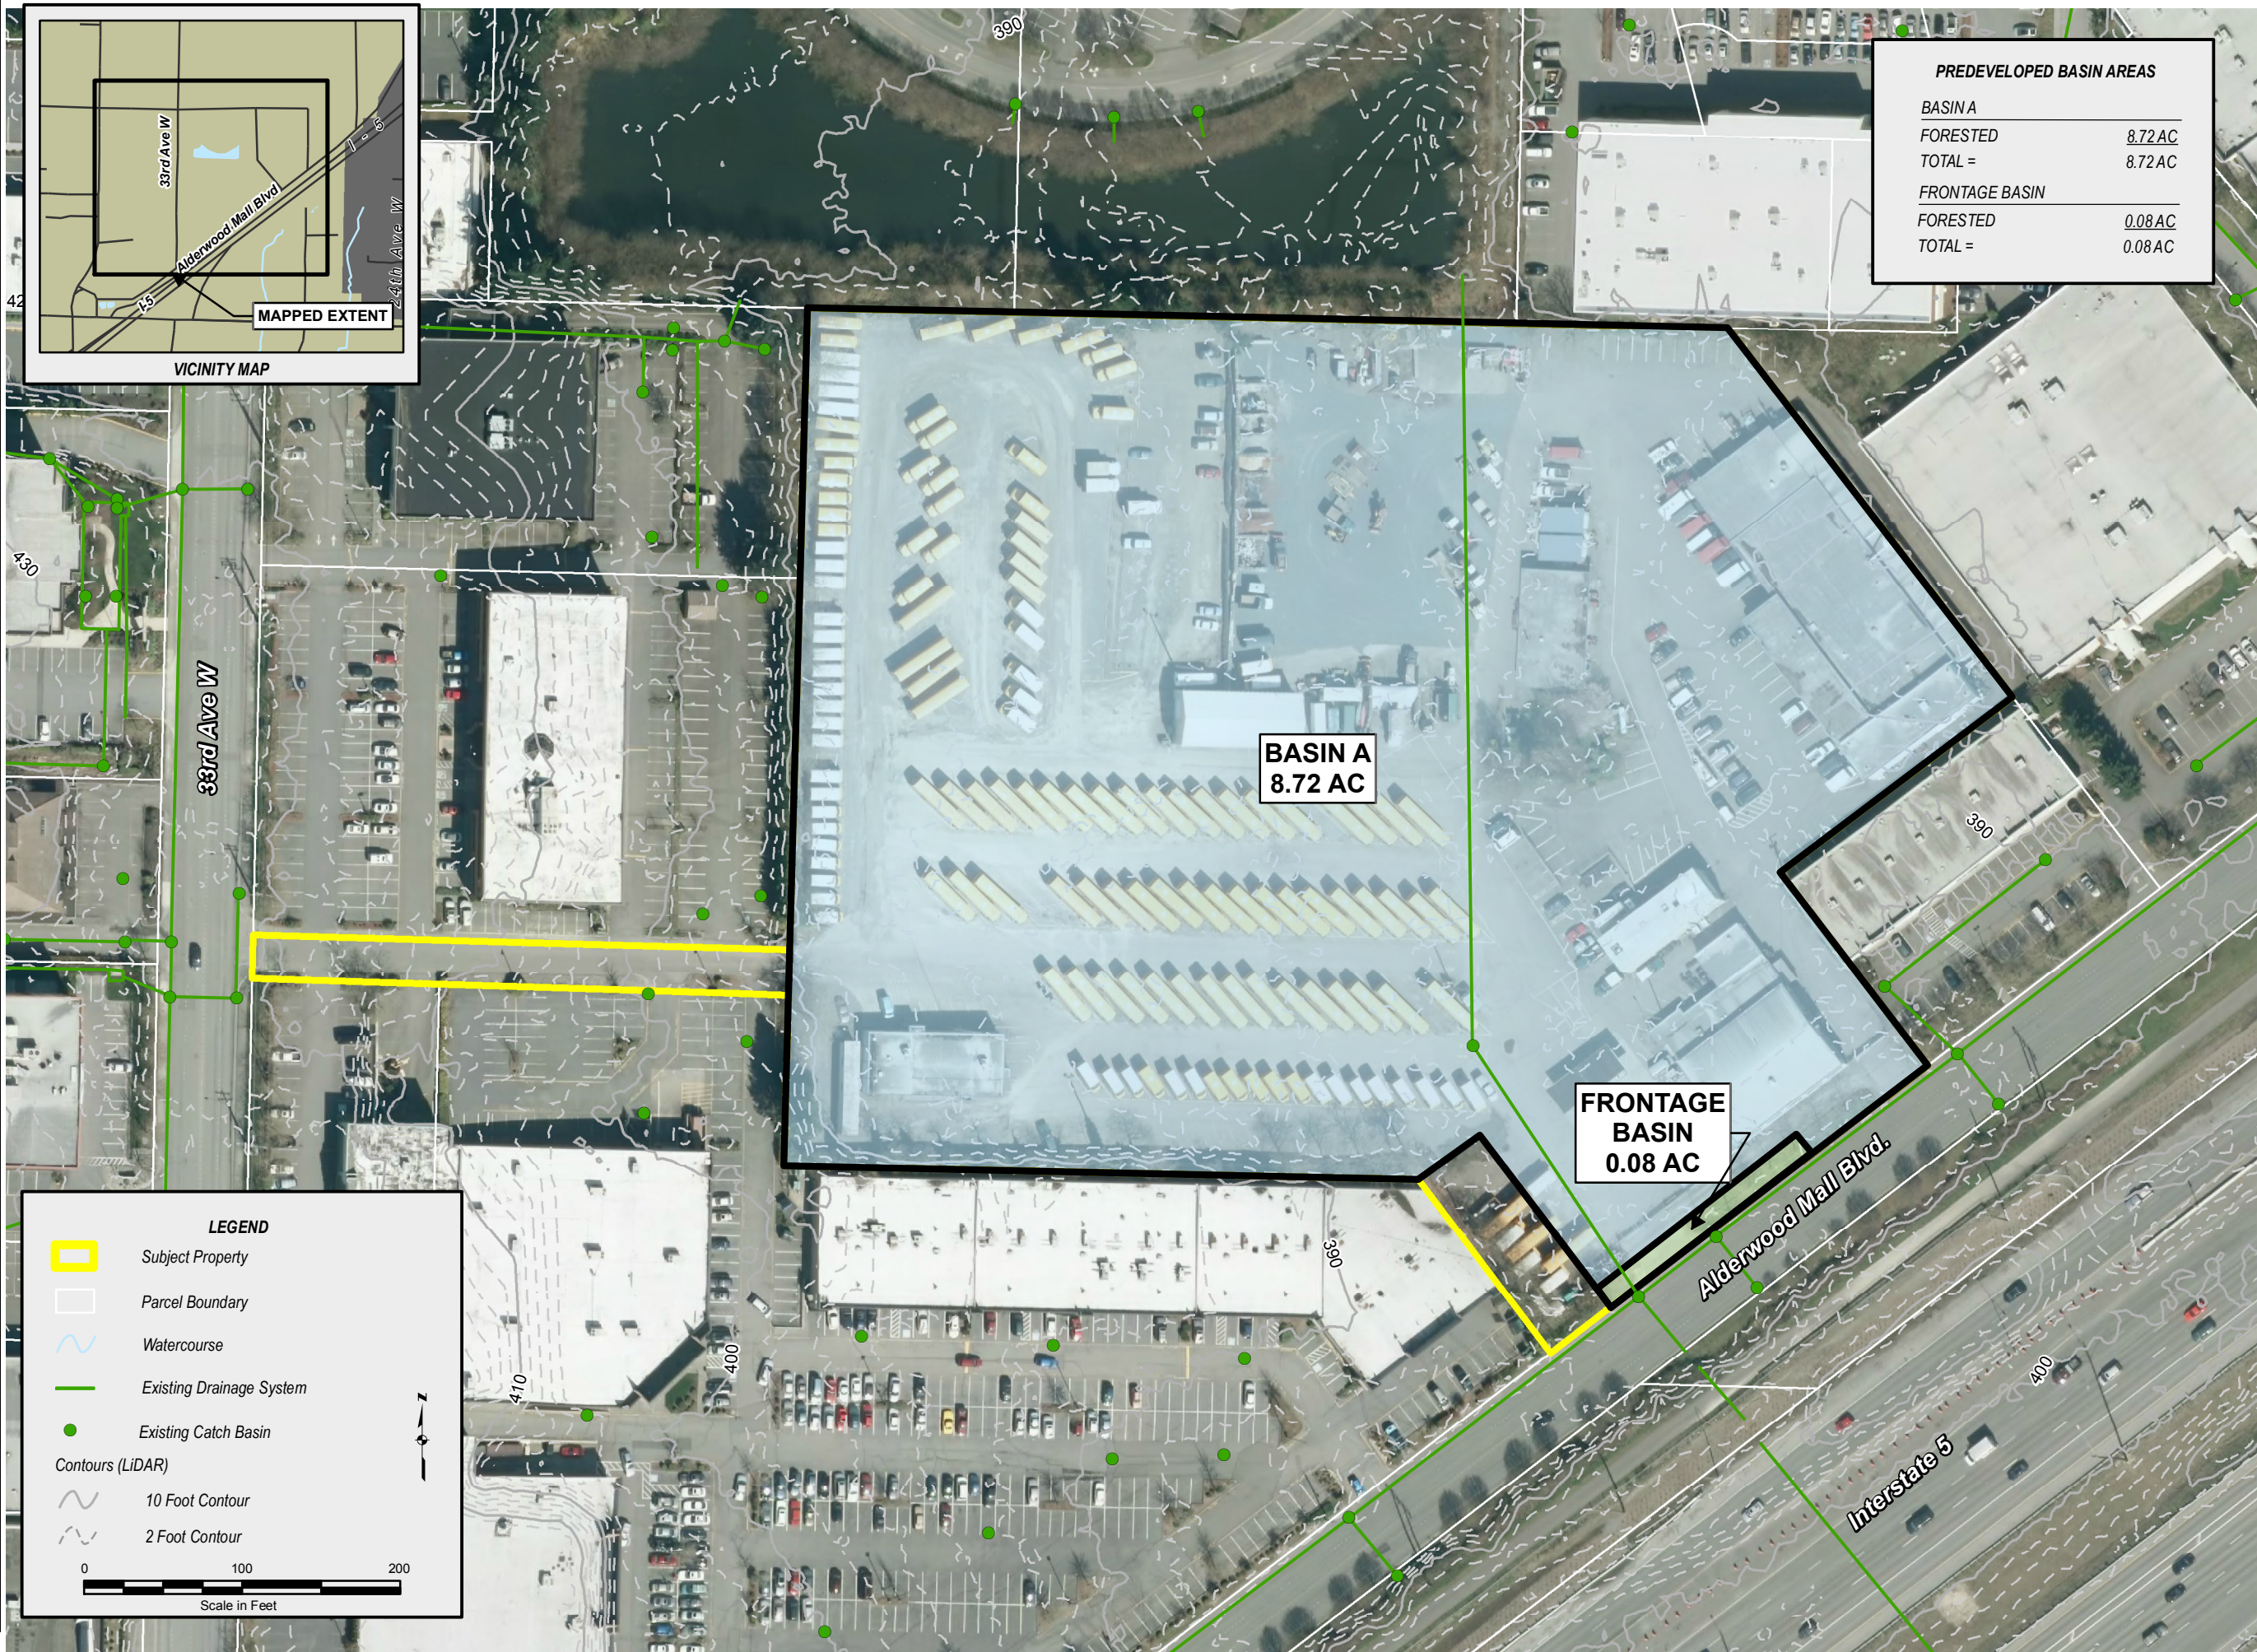
PREDEVELOPED BASIN AREAS	
BASIN A	
FORESTED	8.72 AC
TOTAL =	8.72 AC
FRONTAGE BASIN	
FORESTED	0.08 AC
TOTAL =	0.08 AC

For visual representation of Basins A and the Frontage Basin, see Figure 5.0, “Predeveloped Hydrology Map”. The land cover values for Basins A and the Frontage Basin have been modeled in WWHM2012 as follows:

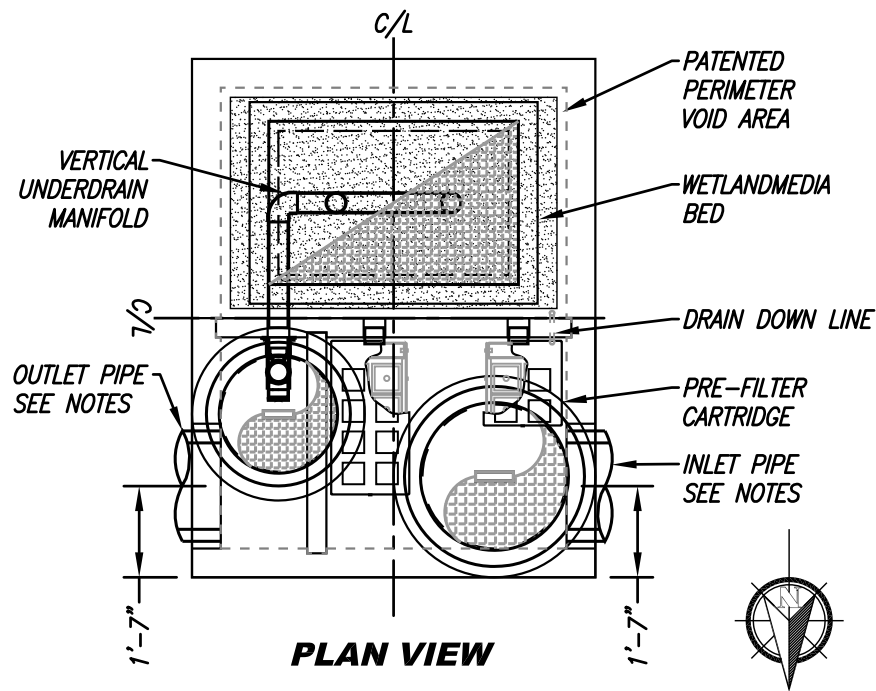
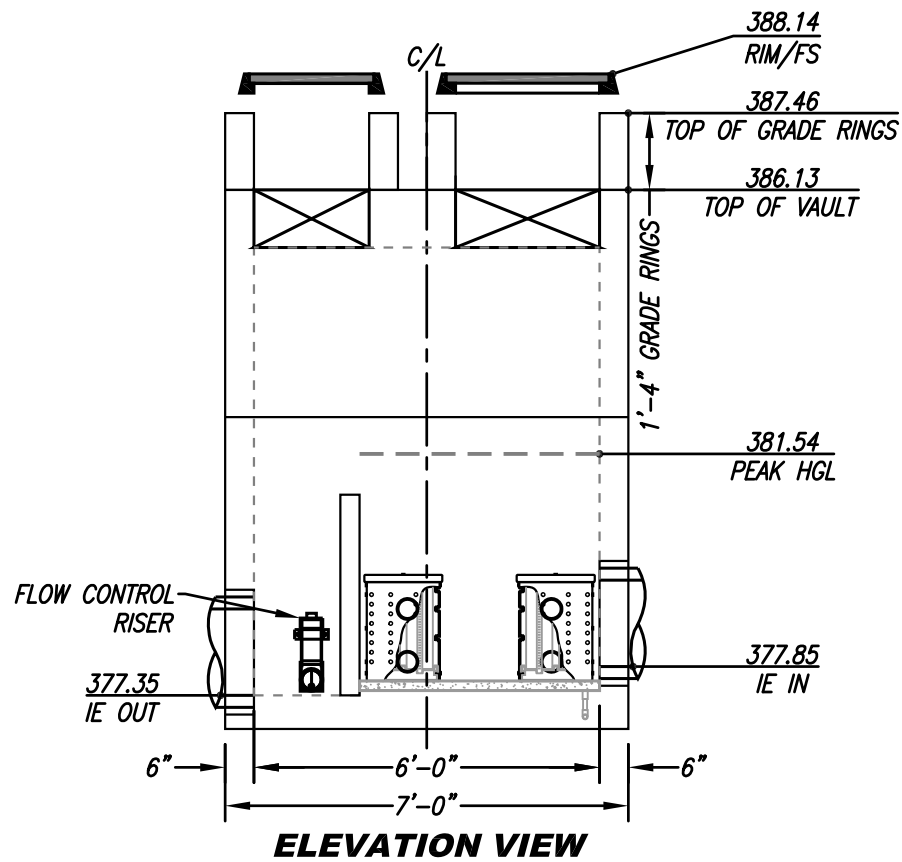
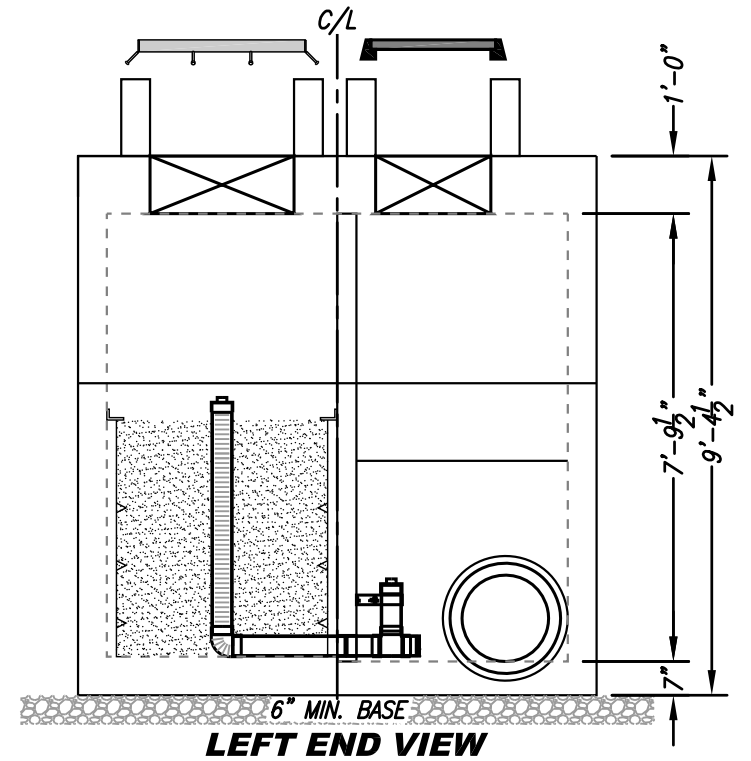
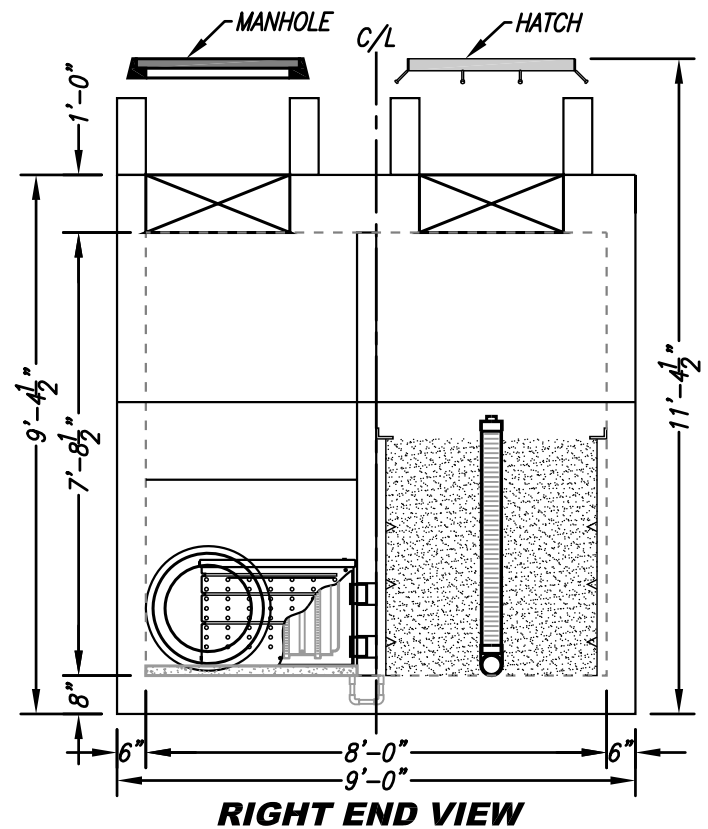
2-YEAR RELEASE RATE (CFS)	0.1374
OPERATING HEAD (FT)	3.4
PRETREATMENT LOADING RATE (GPM/SF)	1.6
WETLAND MEDIA LOADING RATE (GPM/SF)	1.0

Due to the multi-family nature of the project, an “Enhanced” level of water quality treatment will be required for onsite improvements. Water Quality Treatment for developed condition flows within Basin A is accomplished using a Modular Wetland structure located downstream of detention. A summary for the structure and its applicability can be found below. See Appendix 4 for the Modular Wetland standard detail provided by Bio Clean.

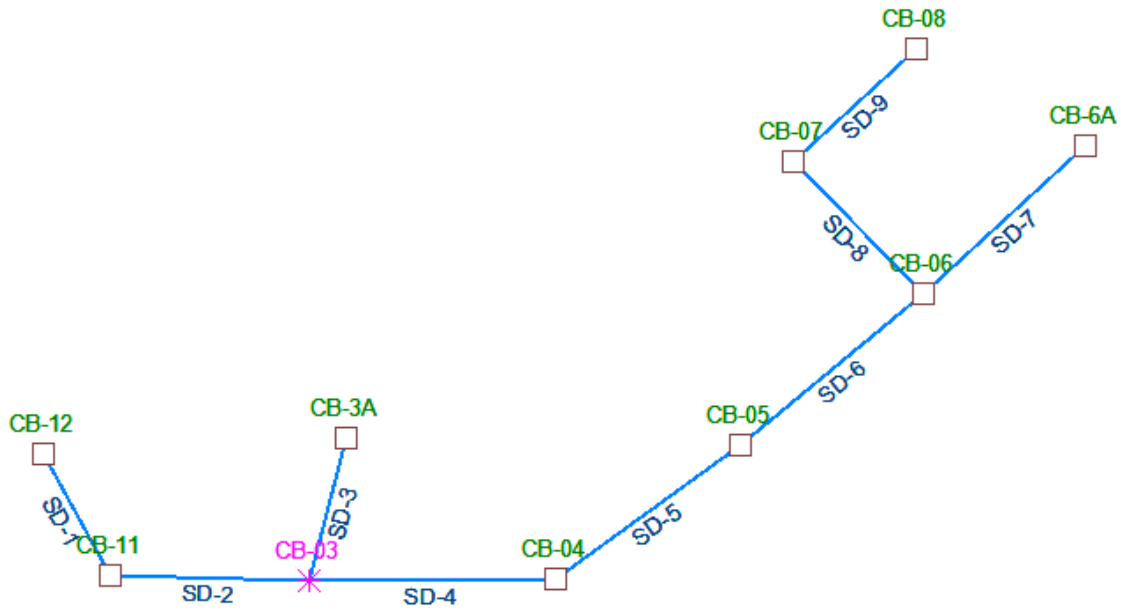
## StormShed Conveyance Model

### Rational Method Analysis - Detention Pipe Tributary System

Reach ID	Area (ac)	TC (min)	i (in/hr)	Flow (cfs)	Full Q (cfs)	Full ratio	nDepth (ft)	Size	nVel (ft/s)	fVel (ft/s)	CArea
SD-1	0.50	5.00	3.4947	1.0344	12.7967	0.0808	0.1919	12 in Diam	9.8145	16.2933	Basin 1
SD-2	1.78	5.0662	3.4679	4.5603	5.8932	0.7738	0.6609	12 in Diam	8.2794	7.5034	Basin 6
SD-3	0.52	5.00	3.4947	1.1463	16.8649	0.068	0.1766	12 in Diam	12.2551	21.473	Basin 9
SD-9	0.49	5.00	3.4947	1.0764	3.7683	0.2856	0.3658	12 in Diam	4.1372	4.798	Basin 2
SD-8	0.68	5.3021	3.3768	1.5229	3.6488	0.4174	0.4506	12 in Diam	4.4353	4.6457	Basin 5
SD-7	0.15	5.00	3.4947	0.3005	3.6731	0.0818	0.1931	12 in Diam	2.8265	4.6768	Basin 4
SD-6	1.21	5.9409	3.1594	2.6002	5.2002	0.50	0.5001	12 in Diam	6.6198	6.6211	Basin 3
SD-5	2.06	6.2632	3.0632	4.264	10.7578	0.3964	0.6571	18 in Diam	5.7271	6.0876	Basin 13;Basin 7
SD-4	2.86	6.6095	2.9683	5.9158	10.7578	0.5499	0.7947	18 in Diam	6.2233	6.0876	Basin 12;Basin 14

The onsite conveyance system was designed for the 50-year, 24-hour storm event (precipitation rate = 3.00 in. obtained from NOAA ATLAS 2, Volume IX), using the Rational Method with Everett IDF Tables. The Uniform Flow Method (Manning's Equation) was performed to ensure that during the 50-year, 24-hour storm event, no catch basin structures would be within 0.5' of overtopping. The conveyance analysis for the drainage system was completed using StormShed 3G and the Rational Method. For visual representation of contributing conveyance basins used in analysis see Figure 7.0 "Conveyance Basin Map" in Appendix 5. Also see Appendix 5 for full Stormshed output data and a map showing the location of all catch basin and pipe numbers analyzed in Stormshed.
